# The Argoflex II Film Advance

Evidence from Ron's Camera

Ron's Argoflex II  
154000156

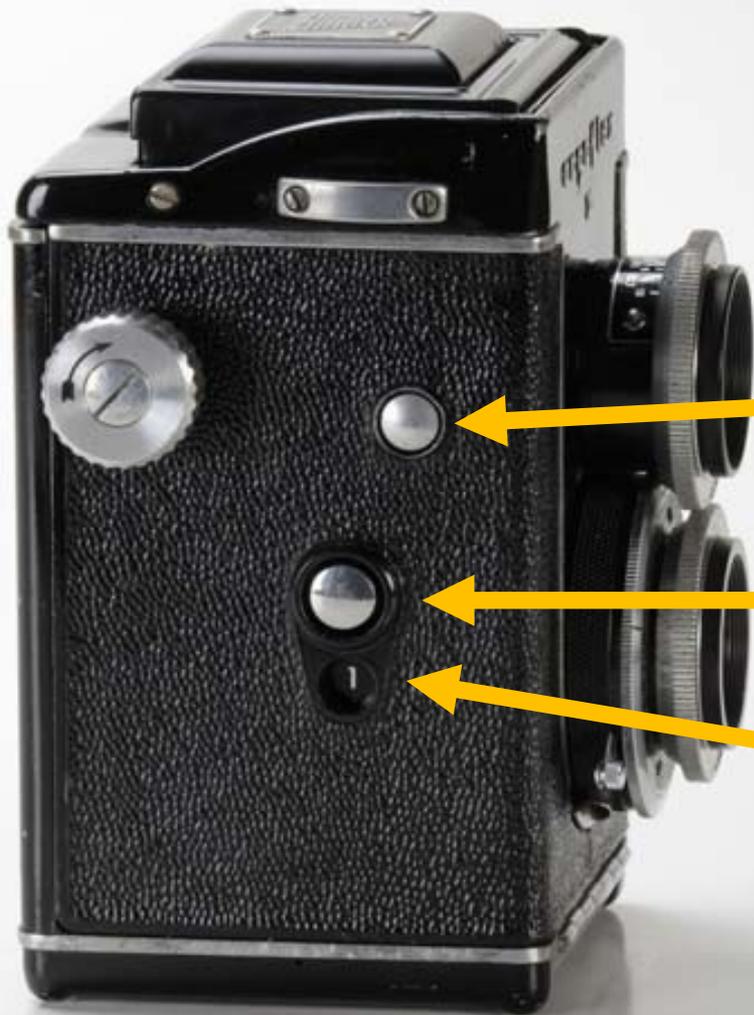
frame advance release

counter reset

frame number

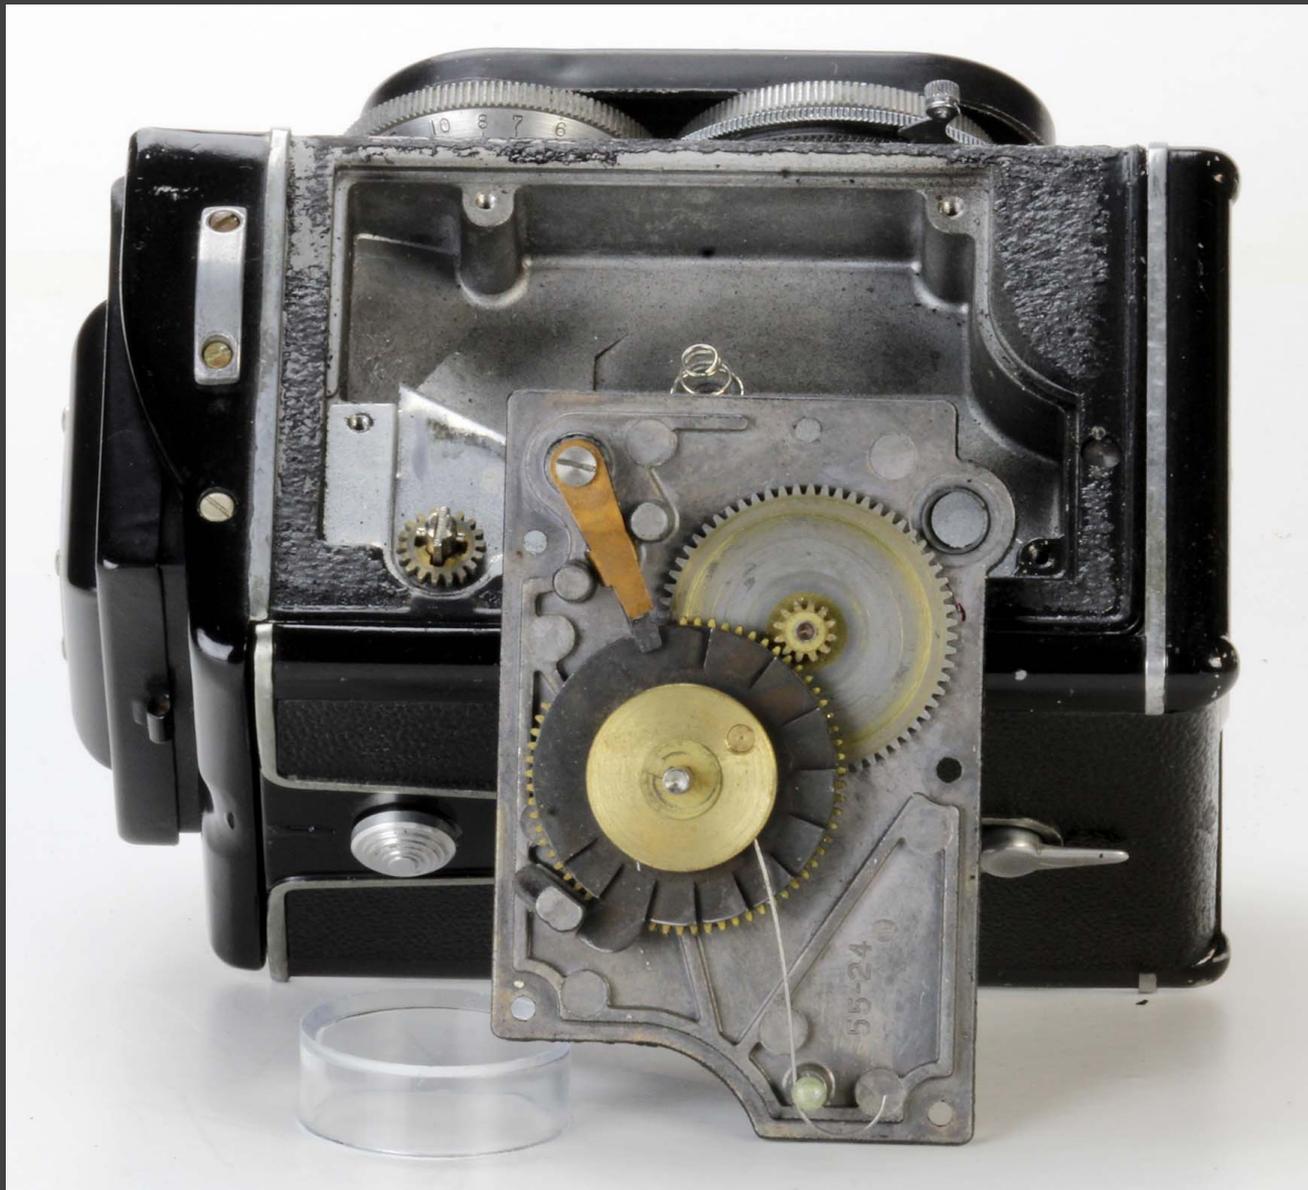
Back of side panel, showing counter

**stopper arm** (stops film advance at next notch on wheel)  
(disengaged by advance release)

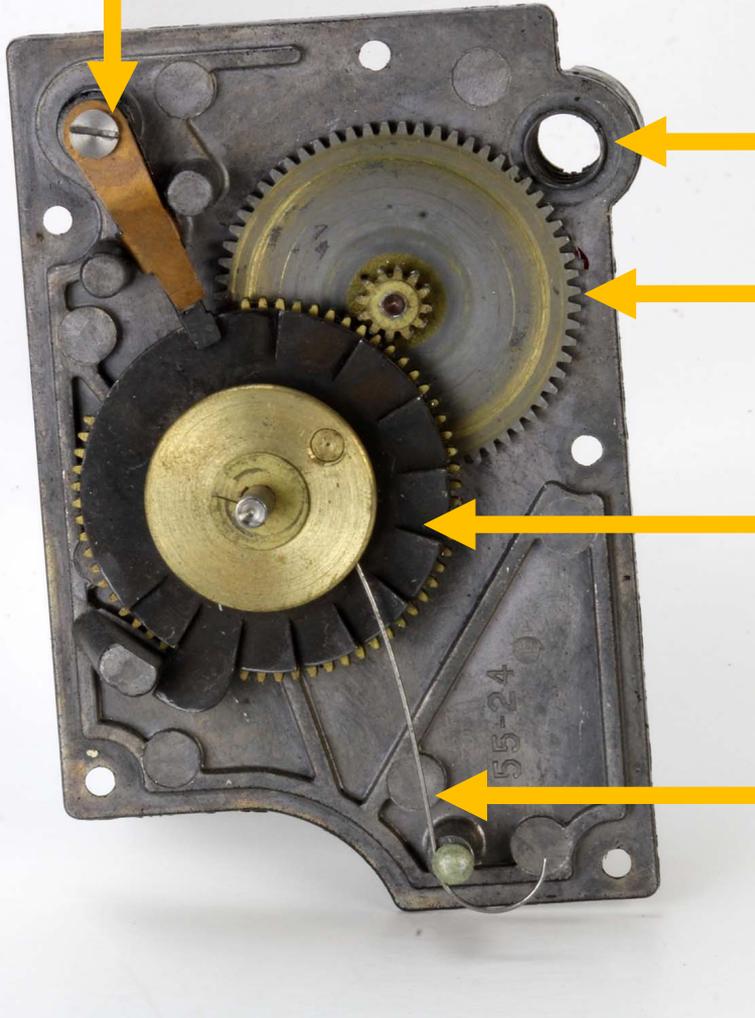
**advance knob hole**

**reducing gears**  
(big and little pressed together)

**notched wheel**  
(12 notches corresponding to frame numbers on the other side)

**coil spring**  
(applies backward torque to the notched wheel)

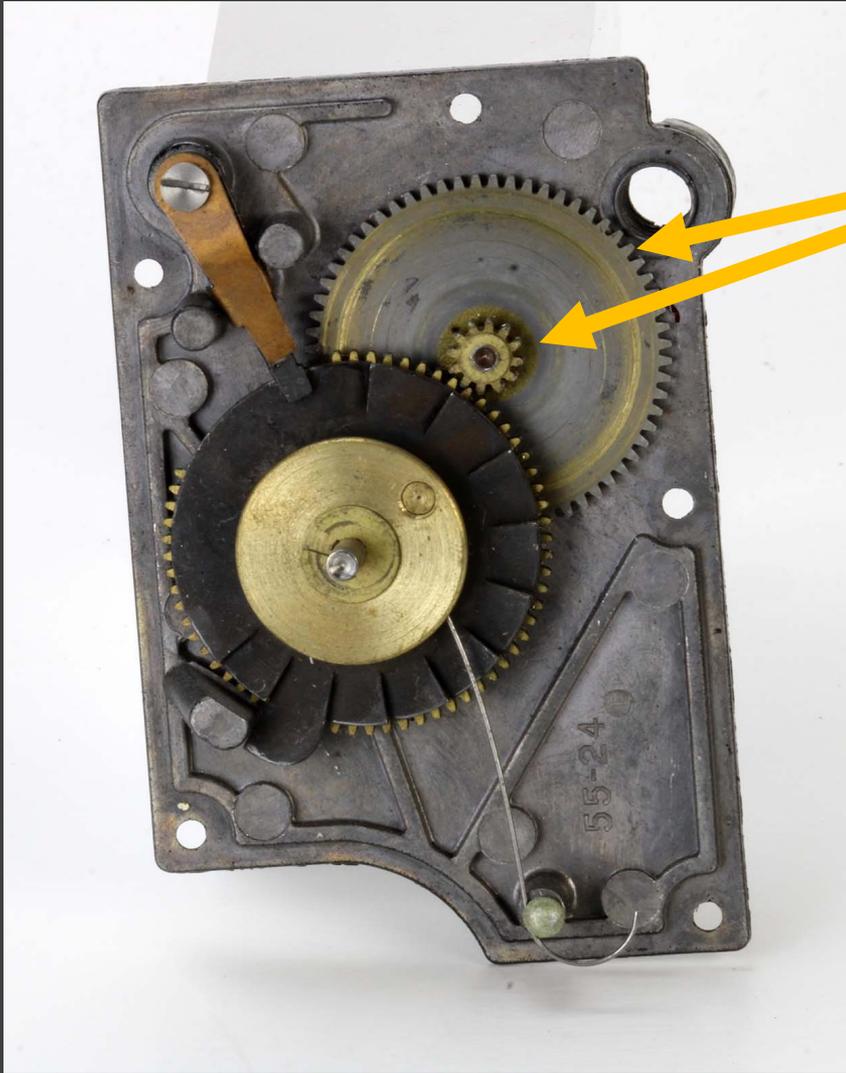
The reducing gears had come apart.

Pressing them together made the counter start to work.

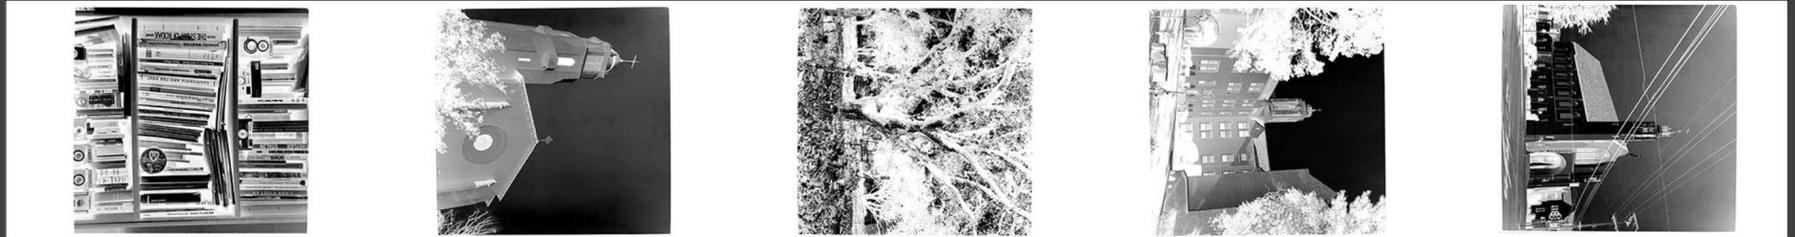
With the gears pressed together,  
another problem:

The separated gears should have been relatively easy to correct in the manufacturing flow. The wide frame spacing appears to be a fundamental problem with the counter design.

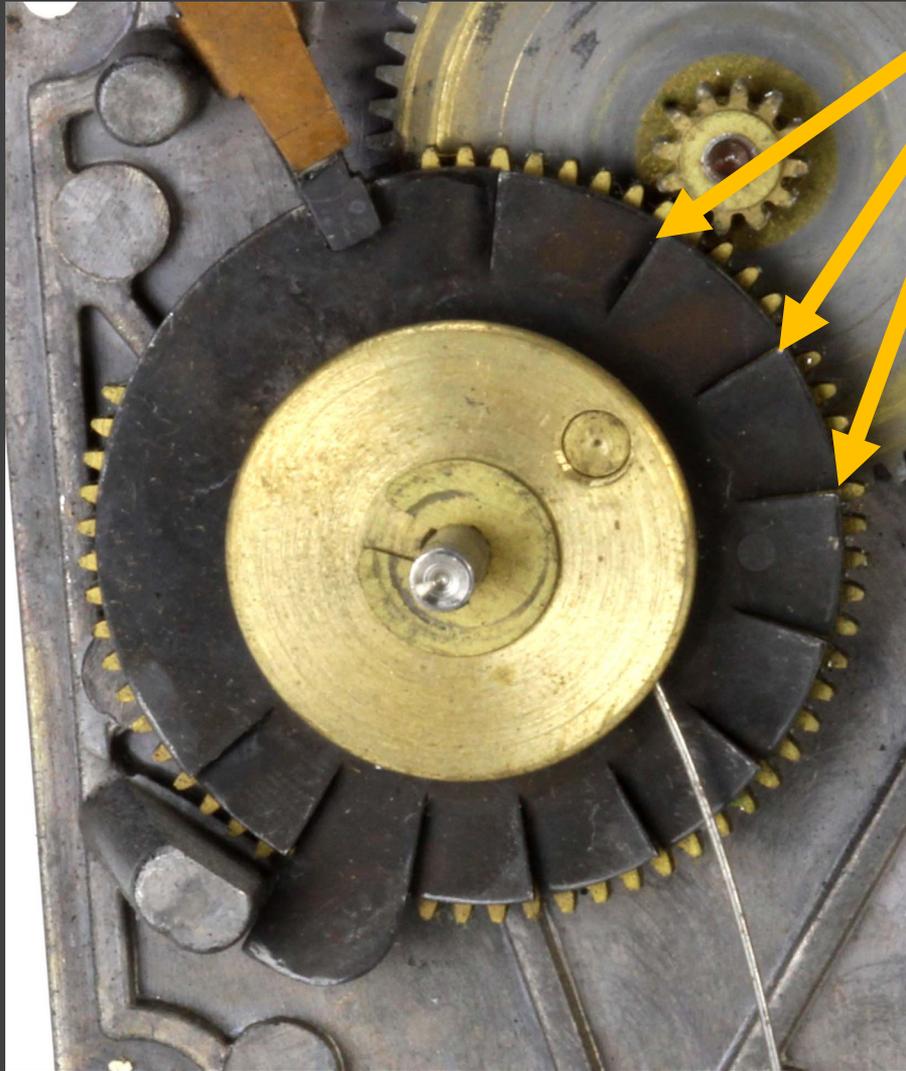
The 12 notches on the notched wheel are what determine the frame spacing. The nominal spacing must be progressively reduced to compensate for the increasing thickness of film accumulated on the take-up spool.

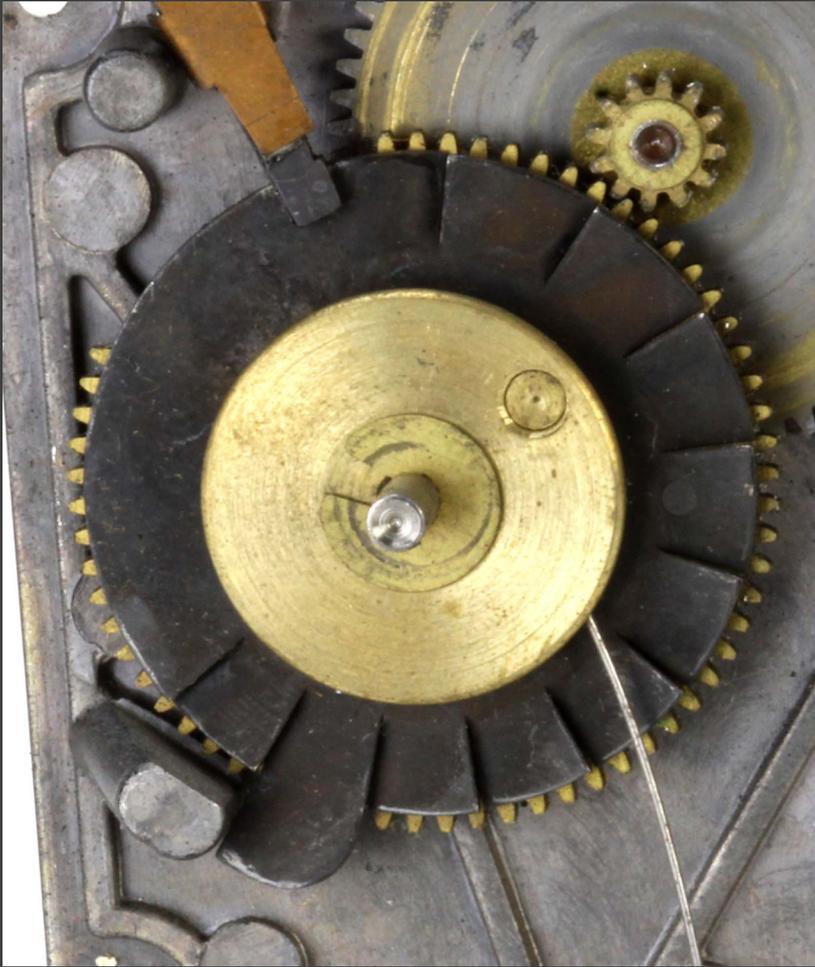
Based on this one example:

Fixing the notch spacing would have likely required a number of iterations and retooling the part.
